# Westmeath Industrial Heritage Survey: sample visits

Westmeath Industrial Heritage Survey: sample visits of 11 sites

Heritage Office, Westmeath County Council, Áras an Chontae, Mullingar, Co. Westmeath N91 FH4N

19<sup>th</sup> November 2020

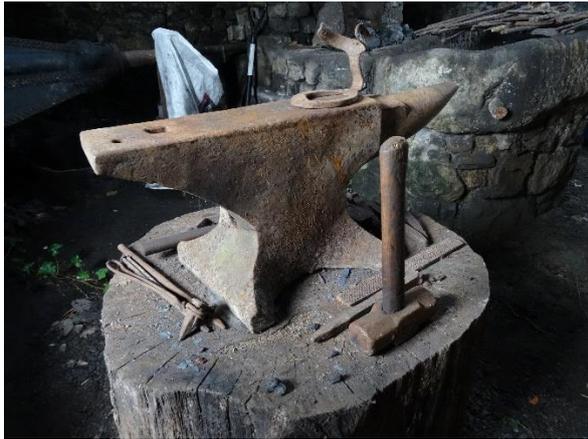
## Forge at Moydrum

### Extant remains:

Two smithies, rear of a small late 19<sup>th</sup> century dwelling, built as part of the estate of Lord Castlemayne. The earlier smithy dated to latest 1870, now replaced by an open shed structure but archaeological remains may be beneath. The later smithy was built in 1910 of limestone, with a brick internal furnace and small chimney. The building runs from north to south, with a large door at the northwest and small windows in the east and west walls. The furnace, trough and tools are intact and in working order and the smithies are still in occasional use. The building is rooved with timber beams and slate.

Originally the forge was to the south of the roadside dwelling, where the large open southern shed is in place today. In 1910, a mortared calp-limestone forge was built, marked on the 1888-1913 OS map. It has a brick furnace extending up the southern wall and connected to a large oval granite trough. East of the furnace, a large blue bellows is pumped using a chain and pulley. Under the east facing window, a clamp, purchased for 25 shillings is attached to a bench, its base settled into a hole in the dirt floor. Nearby stands an anvil on which a prosthetic horseshoe, made by Ernie’s father, Richard, rests. The anvil sits on a large tree trunk, allowing the storage of tools around the anvil. By the west window, stands a clamp operated by a large wheel. From the large, wide door, made to accommodate a horse, the floor consists of large oak timber blocks which stop halfway through the forge, a dirt floor surrounding the furnace. It was there that a skittish horse might be prevailed upon to lie down with the help of a bucket of water. On the north wall are two wheels, 150 years old but brand new and never used, made by a local carpenter. Local road-signs and old AA road-signs are kept safe here, as are the old shoe forms from when people would make their own footwear.

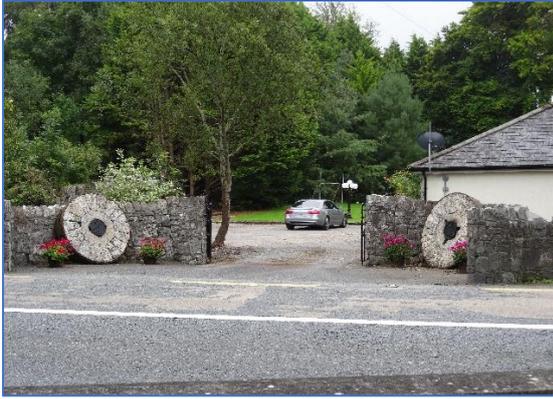
## Ballykeeran Mills

- Mill house extant 1837, extended and present
- Old Corn Mill extant 1837 – southwestern wall standing

- Corn Mill Sluice, under lawn
- Site of Corn Mill extant 1837 and 1888, no surface remains
- Water pump – not visible
- Bleach Mill extant 1837 – not visible
- Site of Possible flour mill under trees – not visible from road

The Mill House was viewed from the outside road. The central portion of the house appears externally intact and elements likely remain inside. It was extended on both sides to the northwest and southeast sometime after the 6<sup>th</sup> Cassini Map (1830s to 1930s). An undated photo, copyrighted by the Historical Picture Archive shows the later northeastern corn mill (then marked still in use) which is now gone. The view is facing south-east from the main road and the house would have been to the right of the photograph. As is visible on the Historic 25<sup>th</sup> map, the mill race continued under the main road and ran along the north of the site to meet the mill (shown on the left of the photograph).

At the gate, two segmented mill stones are displayed. The regular segmentation (18 segments) suggests that they are French burr stones which was used for finer grinding and were likely associated with the corn or the flour mills. The internal octagonal piece of stone is possibly made of a less expensive material. According to a Wikipedia entry, one of the mills in the Ballykeeran was also used as an RIC Barracks. Occ. John Murtagh "House, offices, corn-mill, stone and land" (GV).

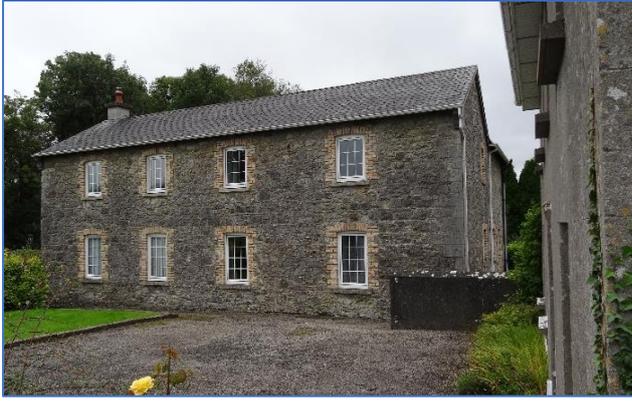
## Annagh Mills

- Possible miller's house/renovated mill building
- Tuck mill partially intact, extended
- Mill race bridge partially intact
- Mill race partially intact

- Corn mill building to northwest
- Mill race partially filled in
- Possible ancillary to east

This site was viewed from the main road. The tuck mill building is present as a dwelling in good condition with an extension to the south. The building north of this may have been a miller's dwelling. A possible pond and part of the mill race have been filled in but the bridge for the road under which the mill race flowed is intact. The pond houses an internal hexagonal section of a mill stone. A well near the pond was not visible. On the eastern side of the road, the mill stream has been culverted and filled in and the ancillary building possibly associated with the corn mill has been lost to the widening of the road.

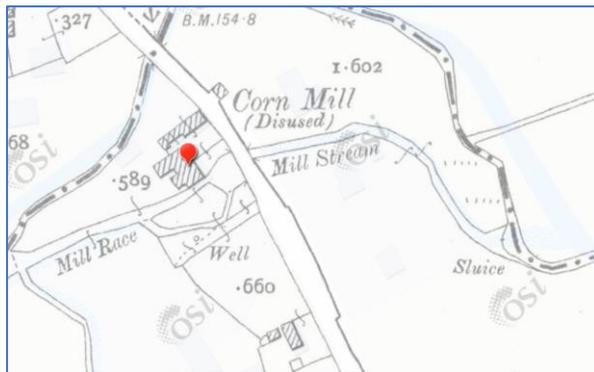
## Annagh Sluice

It is possible that the sluice remains intact at this location as no development has taken place.

A sluice on Breensford River, which was associated with historic Corn and Tuck Mills, 17<sup>th</sup> to 19<sup>th</sup> century. It was not possible to access but examination of aerial photography suggests that the sluice may survive in this undeveloped landscape.

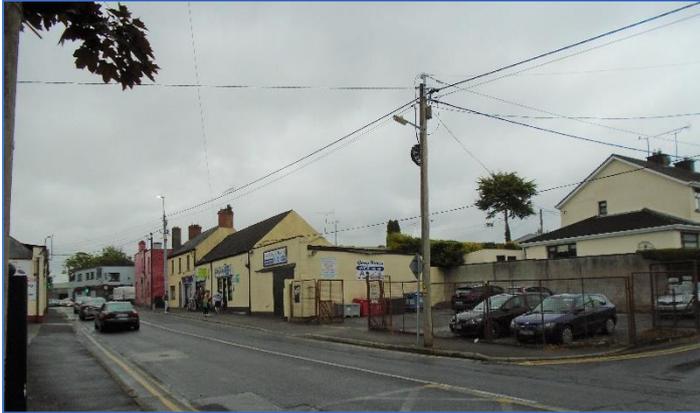
## Mullingar Smithy

This is the site of smithy depicted on 1888–1913 25” OS map. It is now occupied by a 20<sup>th</sup> century single-story commercial building ‘Gerry Hickey Motor Factor’. The son of the owner (Gerry Hickey) recalls the building as a 'forge'. However, the building depicted here on the c. 1910 map does not appear to be the same as the existing modern building, in terms of size or layout, and the existing building has no visible signs of every having been a forge. Some remains of the forge may be under the new building.

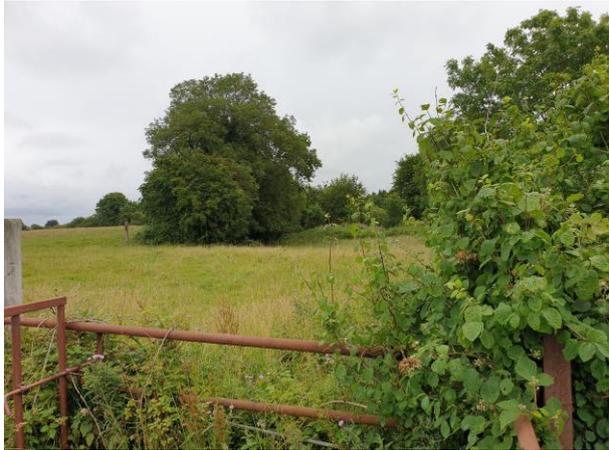
## Ashe Road Quarry

This is the site of a gravel pit depicted on 19<sup>th</sup> century OS maps (First Edition c. 1840 and 25'' 1888-1913) in a field on north side of road. It is currently an undeveloped greenfield site and the former quarry visible as a large irregular depression in the field that is very overgrown.

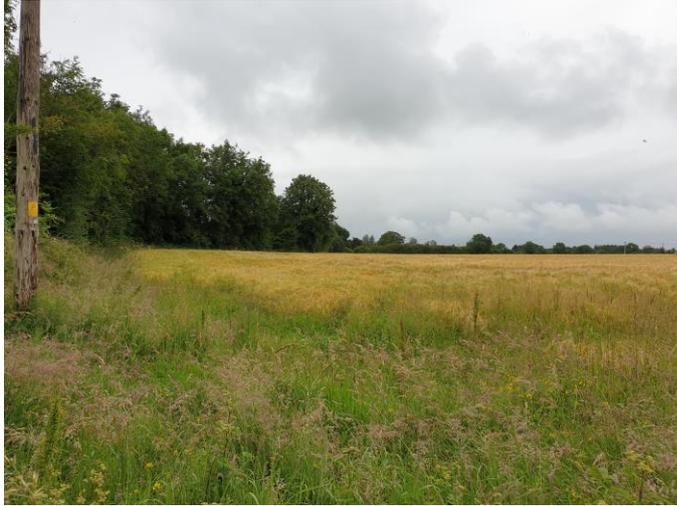
## Harbour Road Lime Kiln

This is the site of a lime kiln in field boundary to north of Harbour Road and alongside canal depicted on 1888-1913 25" OS map. There are no visible surface remains.

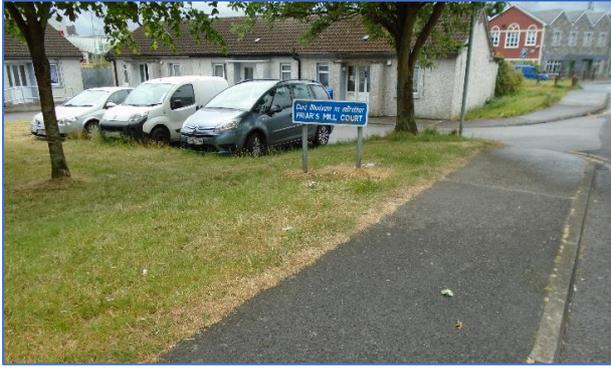
## Pumping Station

There are no visible remains of early 20<sup>th</sup> century pumping station, which replaced a watermill and friary (in ruins in 1837 map). There is a modern private house and access to an apartment complex at site of 'tanks' in the 2<sup>nd</sup> edition 1888 map. There is a car park at location of building opposite tanks.

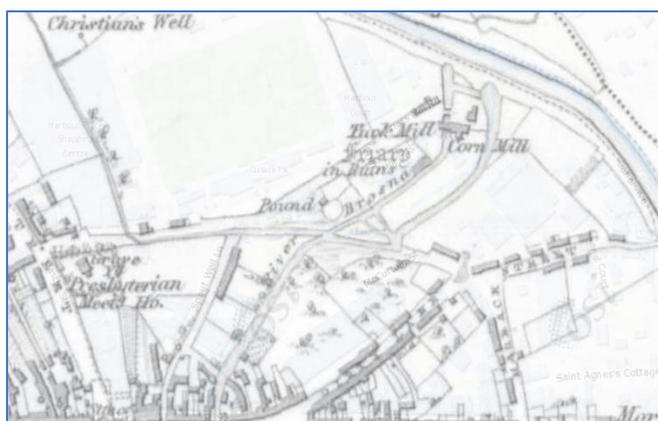
## Friars Mills: Corn, Tuck and Flour

20<sup>th</sup> century houses and a carpark are now on the site of former mill buildings. This mill complex is referred to in 1540; 1631; 1796; 1831; 1837; 1854; 1858; 1860; 1871. Occupied by James Daly, "Corn and Tuck Mill, offices and garden" in the mid-19<sup>th</sup> century (Griffith's Valuation). RMP No.: WM019-089013.

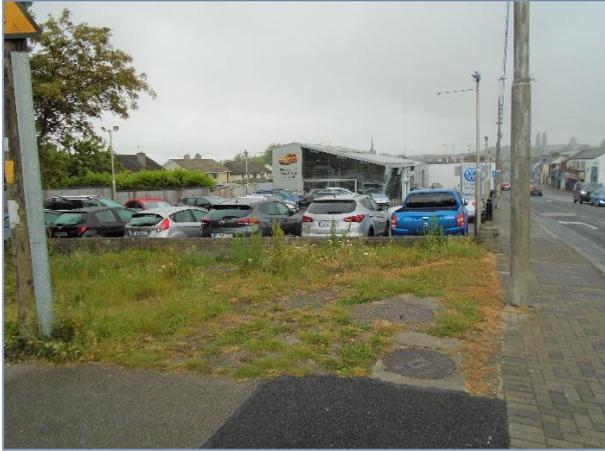
## Mullynnehouny flax mill

No visible remains of any earlier building are the site of a 17<sup>th</sup> century flax mill (RMP No.: WM019-089038-) which was documented in 1641, 1661, and possibly 1682. It is now part of a car sales parking lot and/or modern housing development.

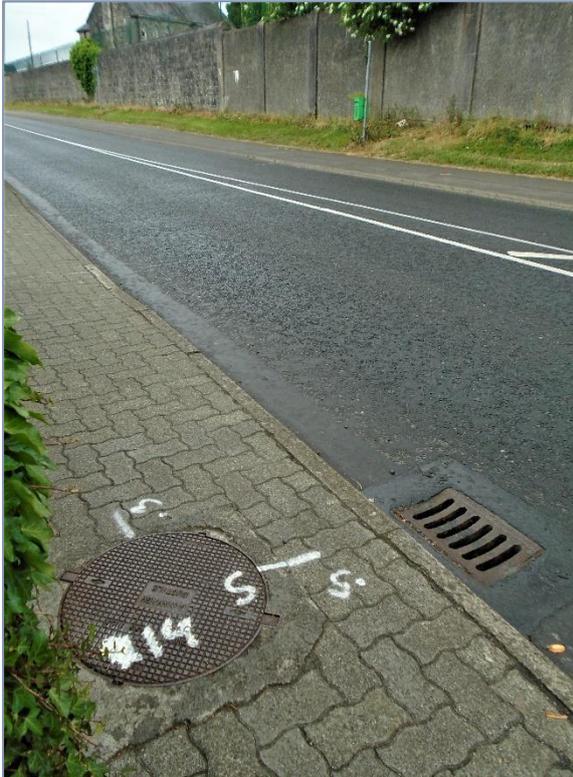
## Ashe Road Water Pump

This is the site of water pump depicted on 1888-1913 25" OS map at Ashe Road. It is at the eastern boundary of the Tesco petrol station. There are no visible remains of a pump. A circular iron manhole cover is at location.
